Case #148

NAME Educational Activities Committee

Cook County Medical Examiner's Office, Chicago, IL

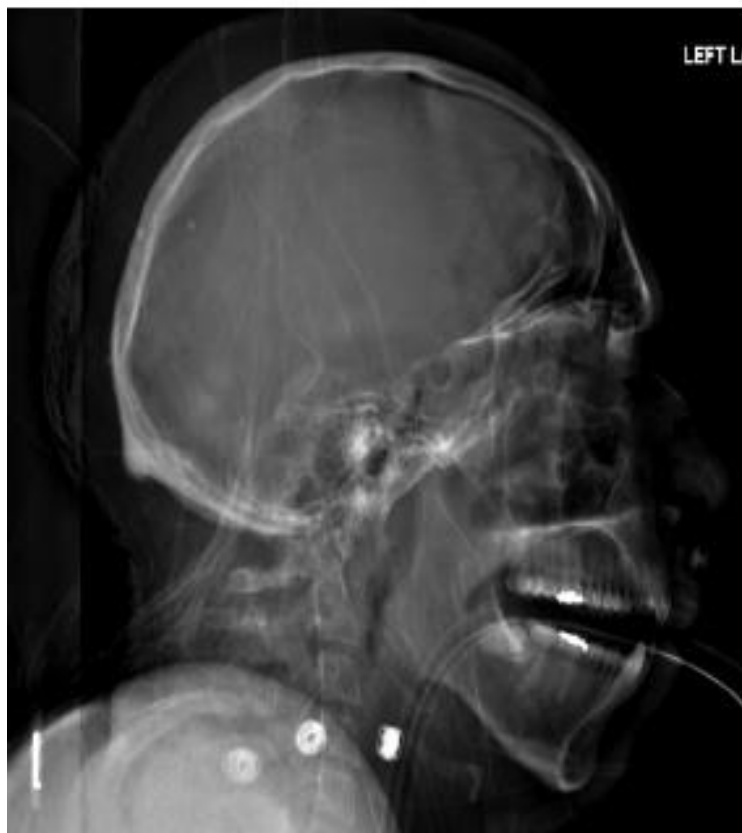
Lateral X-ray with AOD

Severe head–neck hyperflexion/extension such as in a high-speed motor vehicle collisions does not produce the vertical axial loading required for a ring fracture. Instead, this mechanism disrupts the craniocervical ligaments and is a classic cause of atlanto-occipital dislocation. AOD typically results from violent hyperextension, flexion-distraction, or vertical distraction injuries that tear the stabilizing ligaments between the skull and C1.

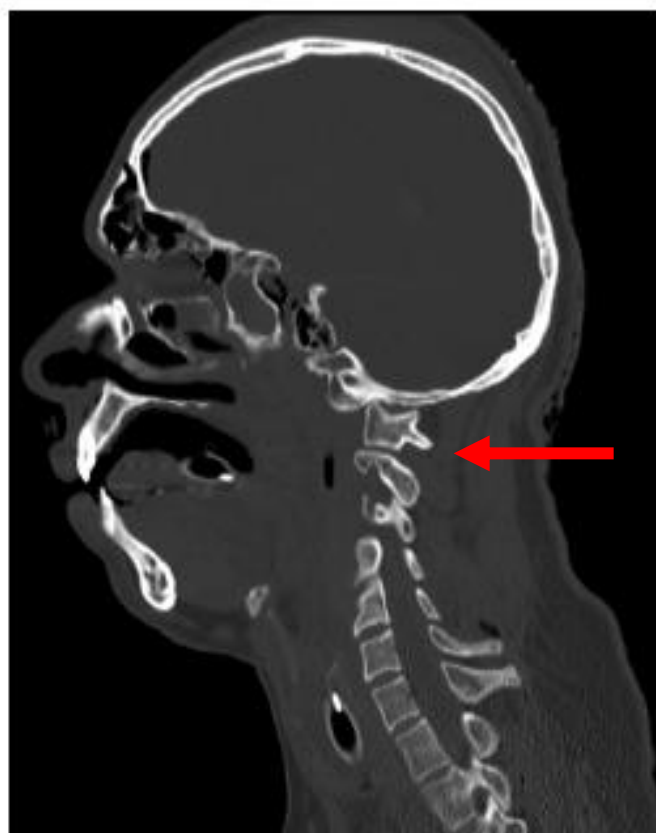
Lateral CT with AOD

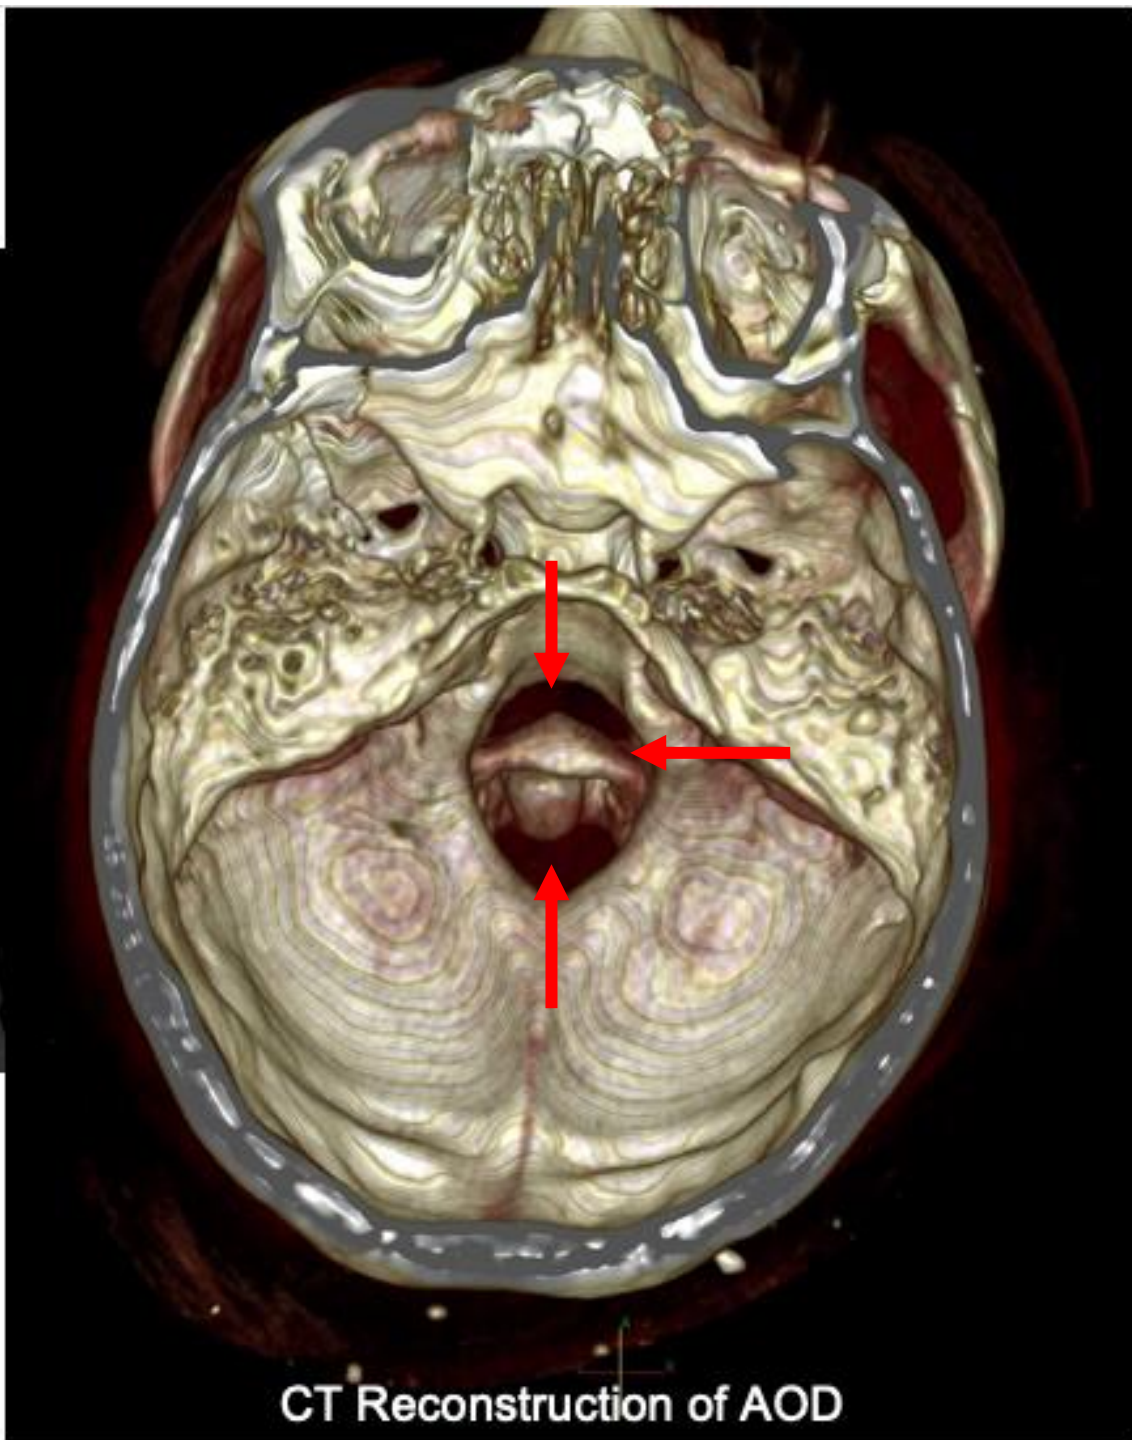
CT Reconstruction of AOD
