Case #72

NAME Educational Activities Committee

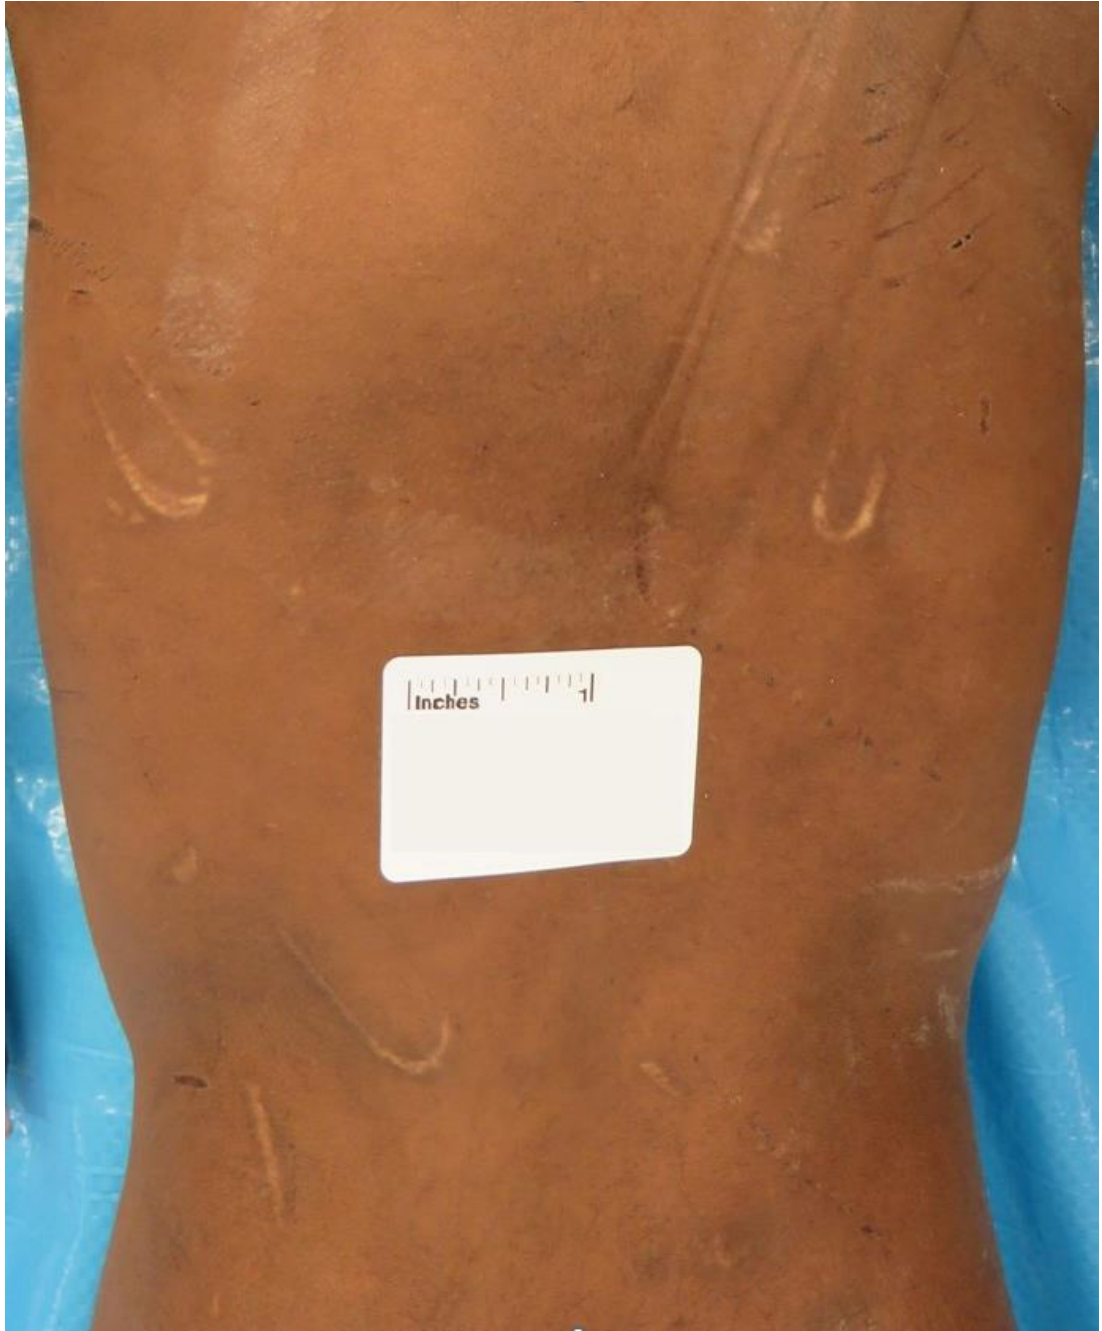
Our image depicts multiple healed patterned injuries on the decedent's back, reportedly consistent with blunt force injuries sustained through beatings with a looped electrical cord.

It is important to note that this pattern is not necessarily specific to an electrical cord. Any other looped object, including many of the other listed answers (e.g., belts, whips, coat hangers, etc...) could be reasonable tools used in inciting these injuries. Additionally, healed burns caused by a curved object, would also be a possible choice.

1. What is the most likely cause for the injuries on this decedent's back? (FREE TEXT ANSWER)

Looped electrical cord – (CORRECT ANSWER)
